Installation Instructions

S67-506

**Push Button Metering Air
Valve For 1F AST
Econowall Shower**

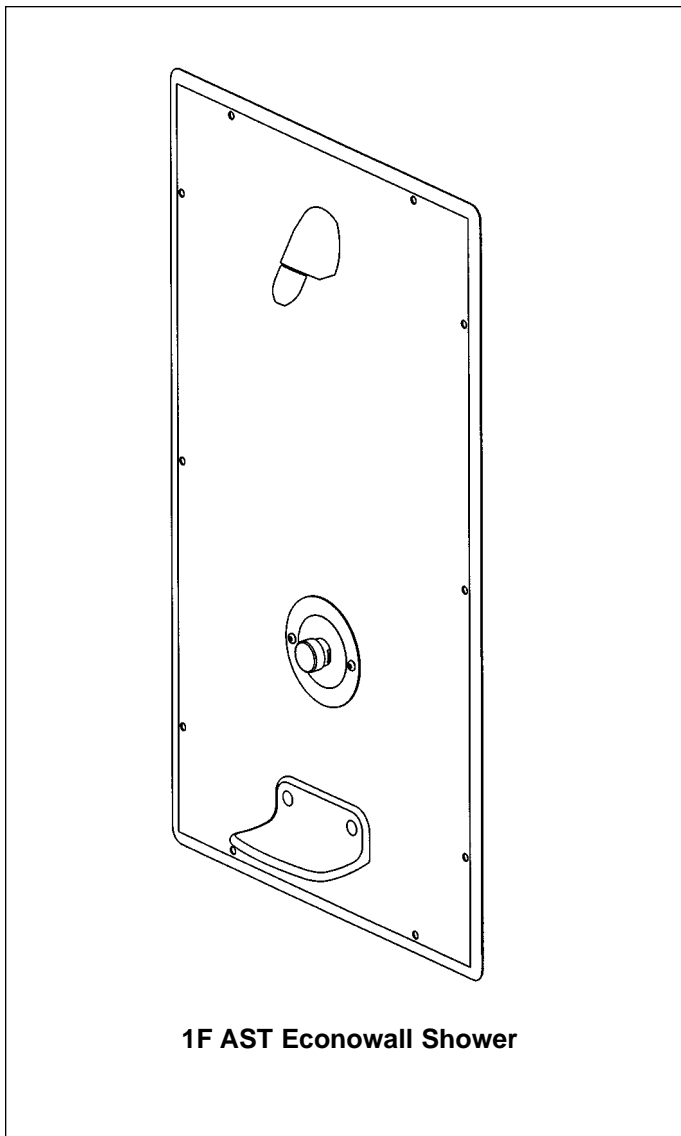
The Push Button Air Valve, when installed onto Bradley's 1F AST Econowall shower, controls water flow through the use of pneumatic metering. When the push button is released, the valve is activated, which then delivers water to the fixture for a preset length of time.

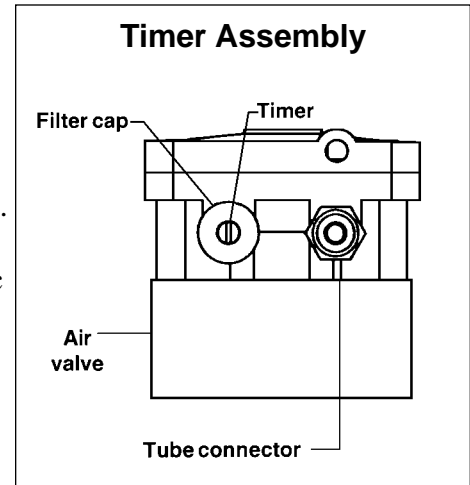
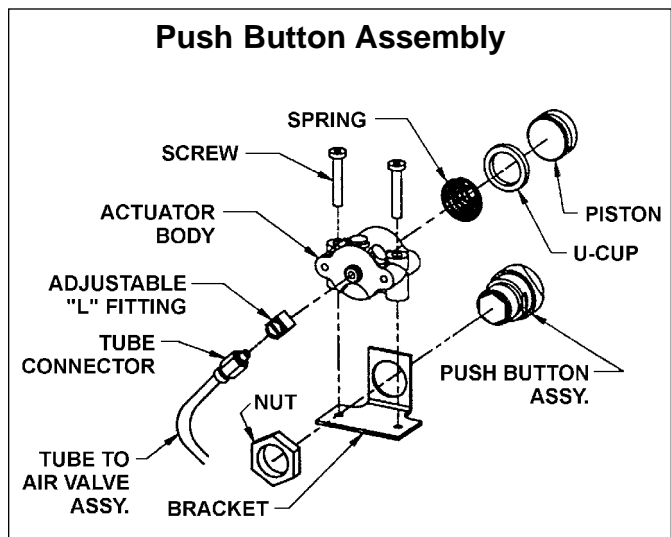
1. Check all fittings for air leaks.
2. Disassemble push button and lubricate U-cup seal (see push button assembly diagram).
