1C Single Compression Valve with Lever Handle For Built-In, Concealed Supply Application

1C Single Compression Valve with Lever Handle

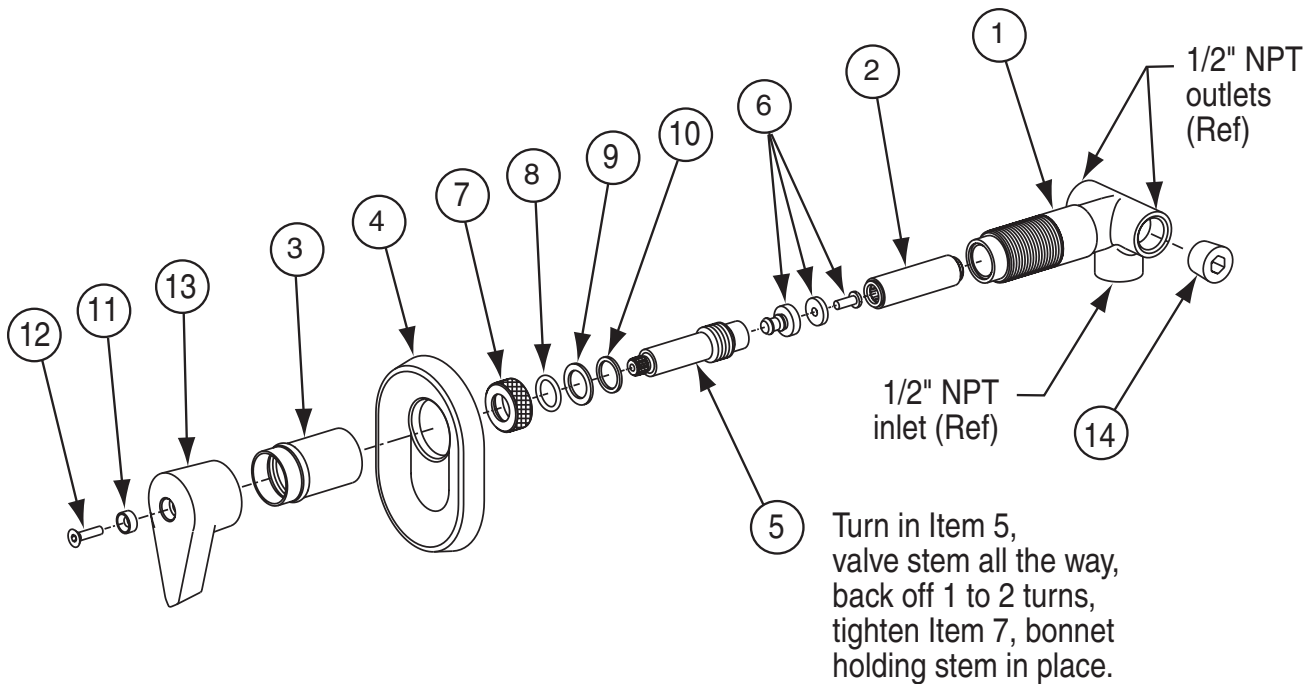
Parts List

Item	Part No.	Description	Assembly S67-507	Valve Stem Assembly S21-070
			Qty	
1	118-146A	Mix Chamber	1	—
2	117-034	Valve Seat	1	—
3	113-430	Escutcheon Sleeve H & C	1	—
4	150-110	Escutcheon	1	—
5	119-244	Valve Stem - Lever Handle	1	1
6	S21-021	Valve Stem Ext Comp	1	1
7	121-019	Bonnet	1	—
8	125-001BC	O-Ring .818" OD	1	—
9	124-001BD	Flat Washer .641 X .938 x .063	1	—
10	142-002BF	Flat Washer .641 x .813 x .063	1	—
11	153-163	Diverter Valve Insert	1	—
12	160-225	Screw 10-24 x 3/4 FL	1	—
13	128-050	Handle	1	—
14	169-168	Pipe Plug - 1/2" Brass	1	—

Counter-clockwise rotation of the handle and valve stem causes the bibb washer to move away from the valve seat allowing water to flow through the valve seat.
