# Case Study

## University of Wisconsin – Milwaukee

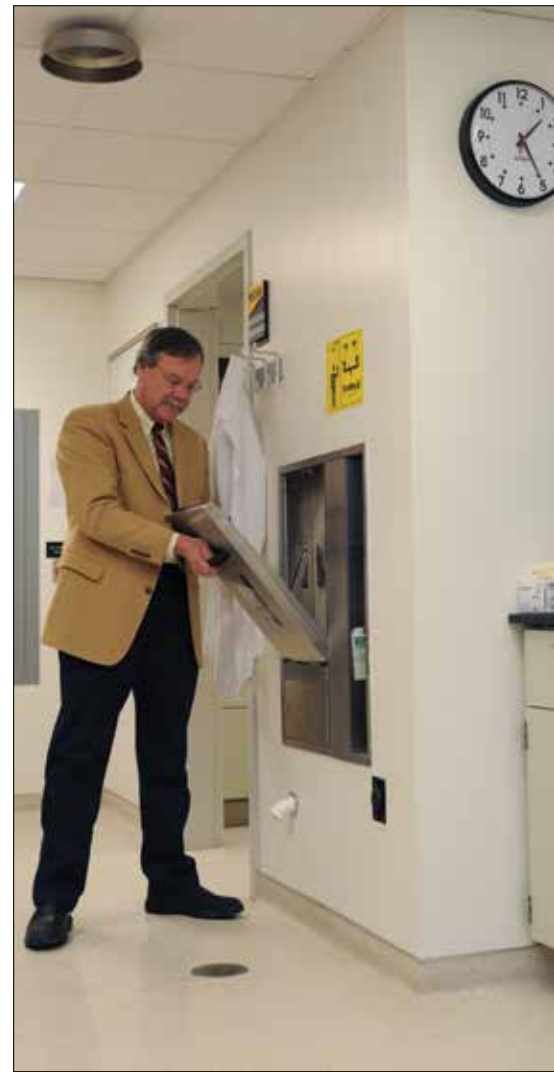
The Barrier-Free Recessed Mounted Drench Shower and Eyewash units (Model S19-315BF) installed at UWM are flush mounted to the wall, making them fully accessible to individuals with physical disabilities and ideal for areas where space is a concern.

The S19-315BF unit complies with American National Standard Z358.1-2004 and is completely flush with the wall - even the pull-down shower handle does not protrude. No tight pinching or grasping is required to operate it.

The concealed eyewash activates immediately when the front cabinet door is pulled down. Water collects in the door assembly and is directed back into the wall.

The Barrier-Free Recessed Mounted Drench Shower and Eyewash unit is designed in a sturdy one-piece cabinet for quick and easy installation, and maintenance is made easy with a wide-access panel. The brass stop-valve, tailpiece and fittings for the eyewash are hidden behind a locked, hinged door for convenient, yet restricted access.
